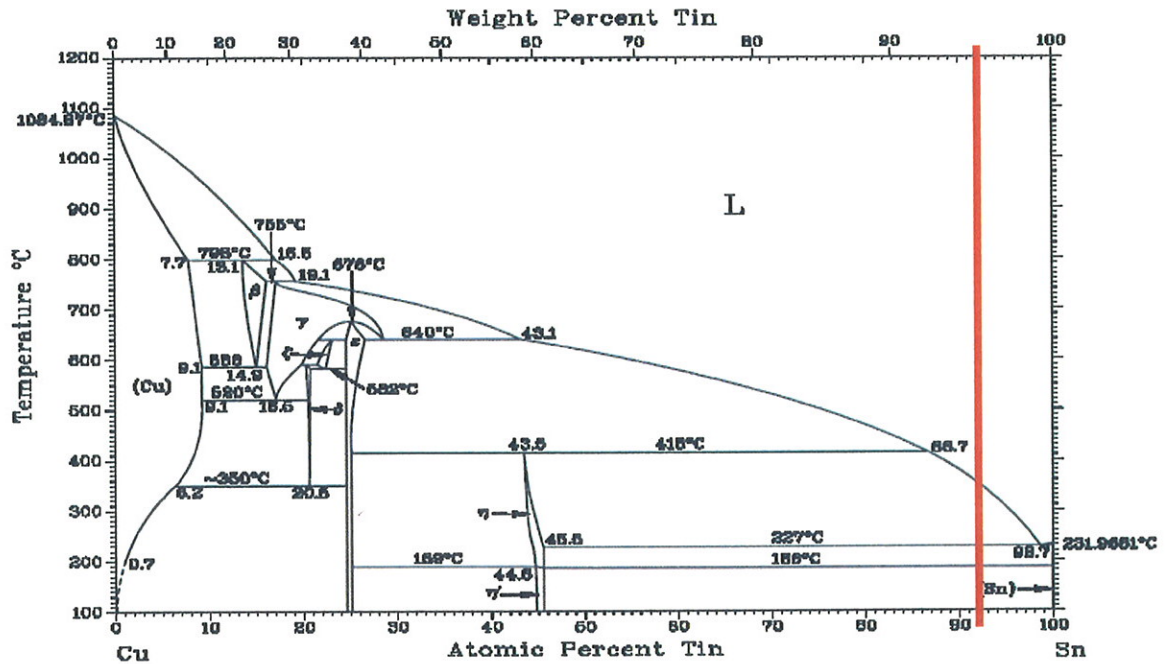
The first three questions can be answered by considering the metallurgy of the copper/solder/brass joint. This joint consists of copper and brass bonded by a thin layer of solder. The solder in this case was predominantly a tin/copper alloy. Since copper has limited solid solubility in tin, the microstructure of this alloy consists of two distinct phases: η (50:50 copper:tin) and tin, as indicated by the copper-tin alloy phase diagram in Figure 32. As previously shown, the brass in both fittings contained lead as a distinct, pure lead phase. Therefore, at the brass/solder interface, essentially pure tin is in intimate contact with pure lead.

Figure 32. Copper-Tin alloy phase diagram. The red line indicates the approximate composition of the "100% Watersafe" brand solder used by Mr. Kemp.

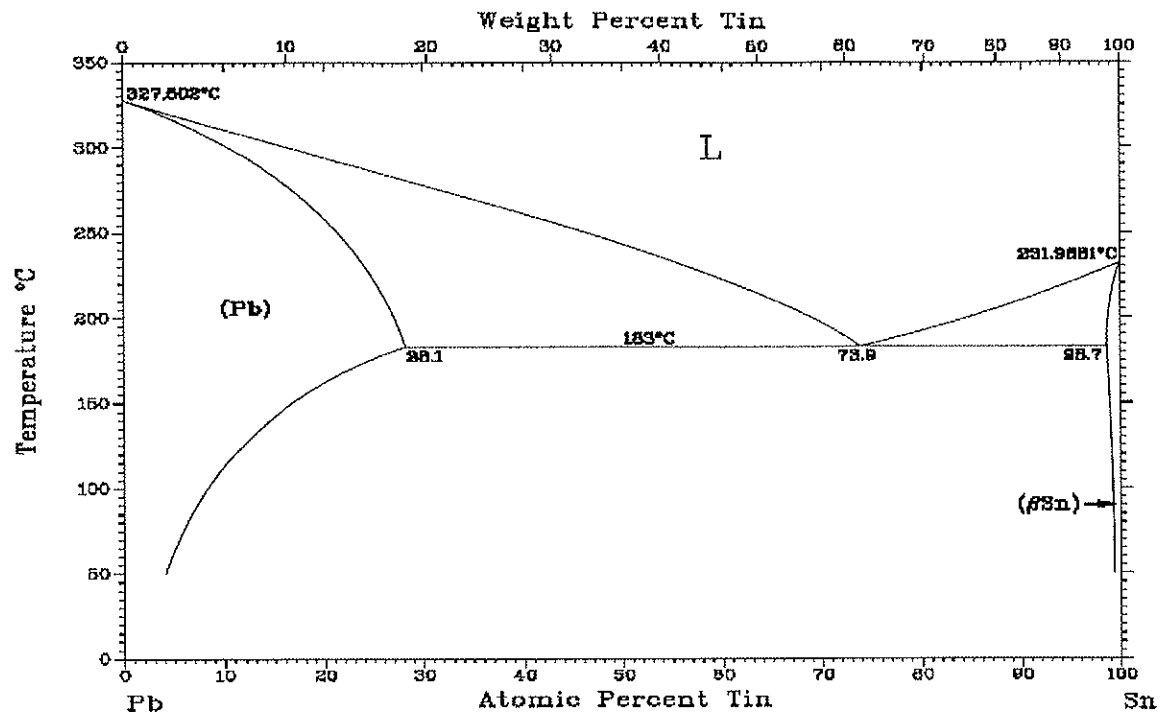
The lead-tin alloy phase diagram shown in Figure 33 shows the consequences of this metallurgical coupling. As shown from this diagram, an alloy of lead and tin has a lower melting point than either of the pure metals. This diagram also shows that if a piece of pure tin is placed in intimate contact with a piece of pure lead and the temperature of this couple is increased, a layer of liquid metal will with a composition of 74% tin, 26% lead will form at 183 °C (361 °F). The same is true at the solder/brass interface on a microscopic level. Everywhere lead from the brass is in intimate contact with the tin phase in the solder, a film of liquid metal will form when the temperature is 361 °F or higher. Therefore, the region of solder in contact with the brass surface has an effective melting point that is 57 °F to 79 °F lower than the bulk solder alloy (418 °F - 440 °F).

Figure 33. Lead-Tin phase diagram.

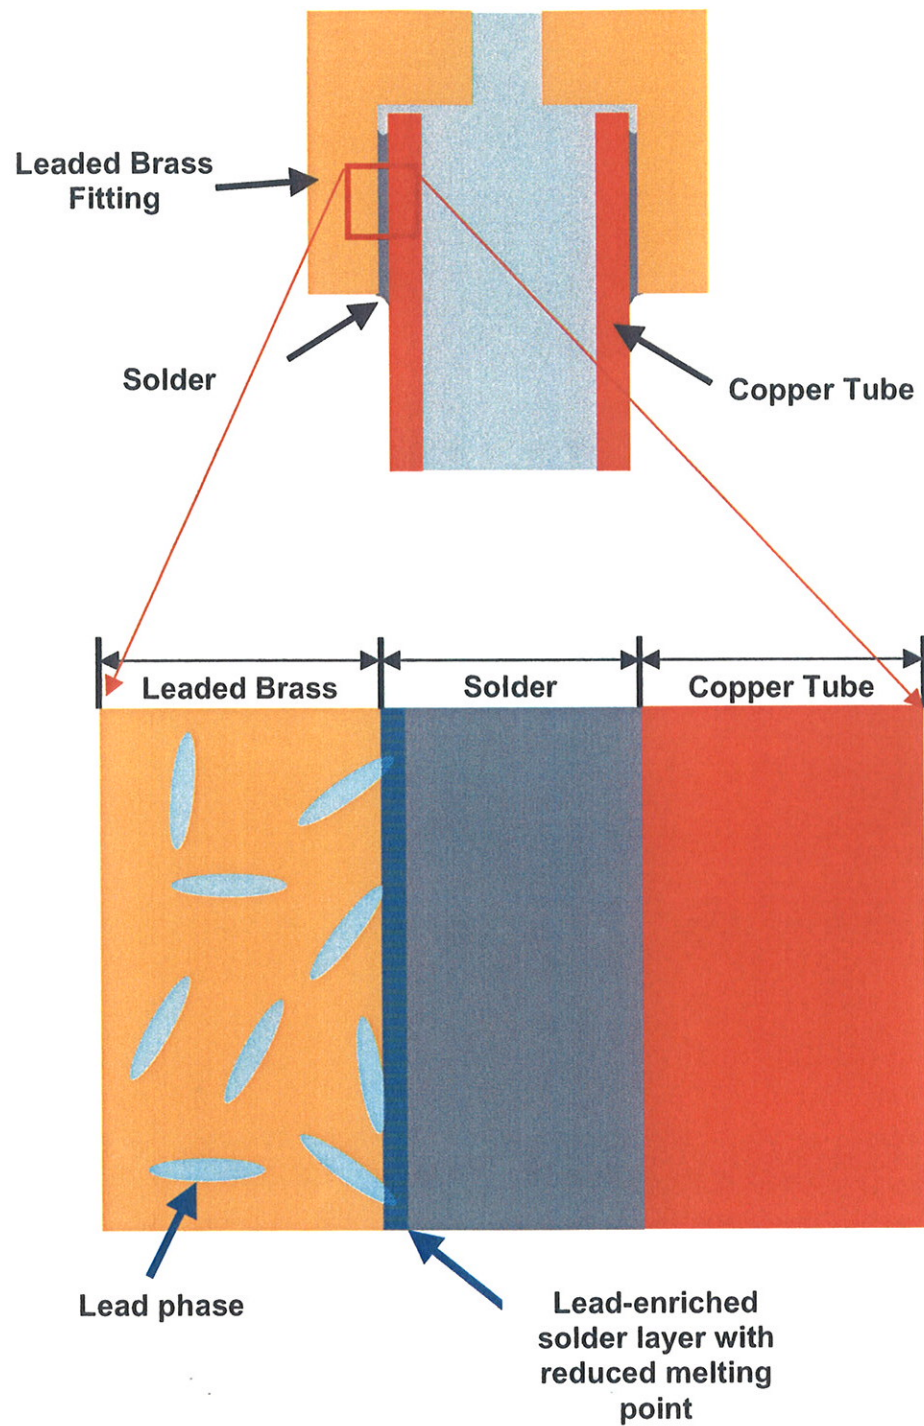
This effect is shown schematically in Figure 34, and it can be used to answer the first three of the four questions presented above. First, because the solder only melts at the brass/solder interface, the joint can be separated without melting the most of the solder. Therefore, Joint Sections 1 and 2 can be separated without melting the solder ridge around the copper tube. Second, since the brass/solder interface melts at a lower temperature, the brass/copper joints will separate before the copper/copper joints. Third, since the solder only melts at the brass/solder interface, the majority of the solder is left on the copper tube.

Figure 34. Schematic of a leaded brass fitting soldered to a copper tube.
